SOME ENGINEERING PROBLEMS OF THE PANAMA
CANAL IN THEIR RELATION TO GEOLOGY
AND TOPOGRAPHY

DONALD F. MACDONALD

WASHINGTON
GOVERNMENT PRINTING OFFICE
1915

Bulletin 86

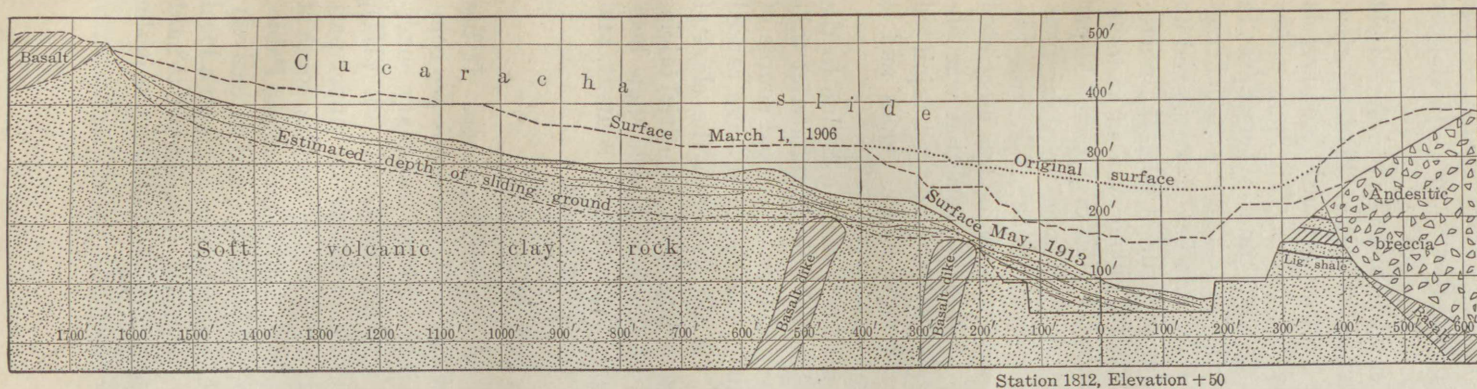
FIGURE 3.—Cross section of Culebra Cut through Cucuracha slide.

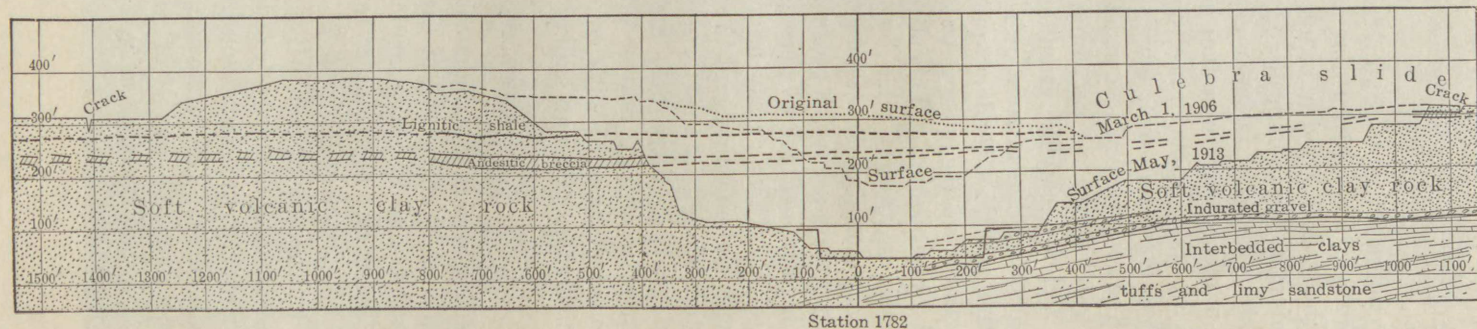
FIGURE 4.—Cross section of Culebra Cut at station 1782. As shown on left, a large crack developed at the surface, due to the fact that the rocks have deformed the excavation. This figure and figure 3 illustrate at what flat angles these rocks will slide.

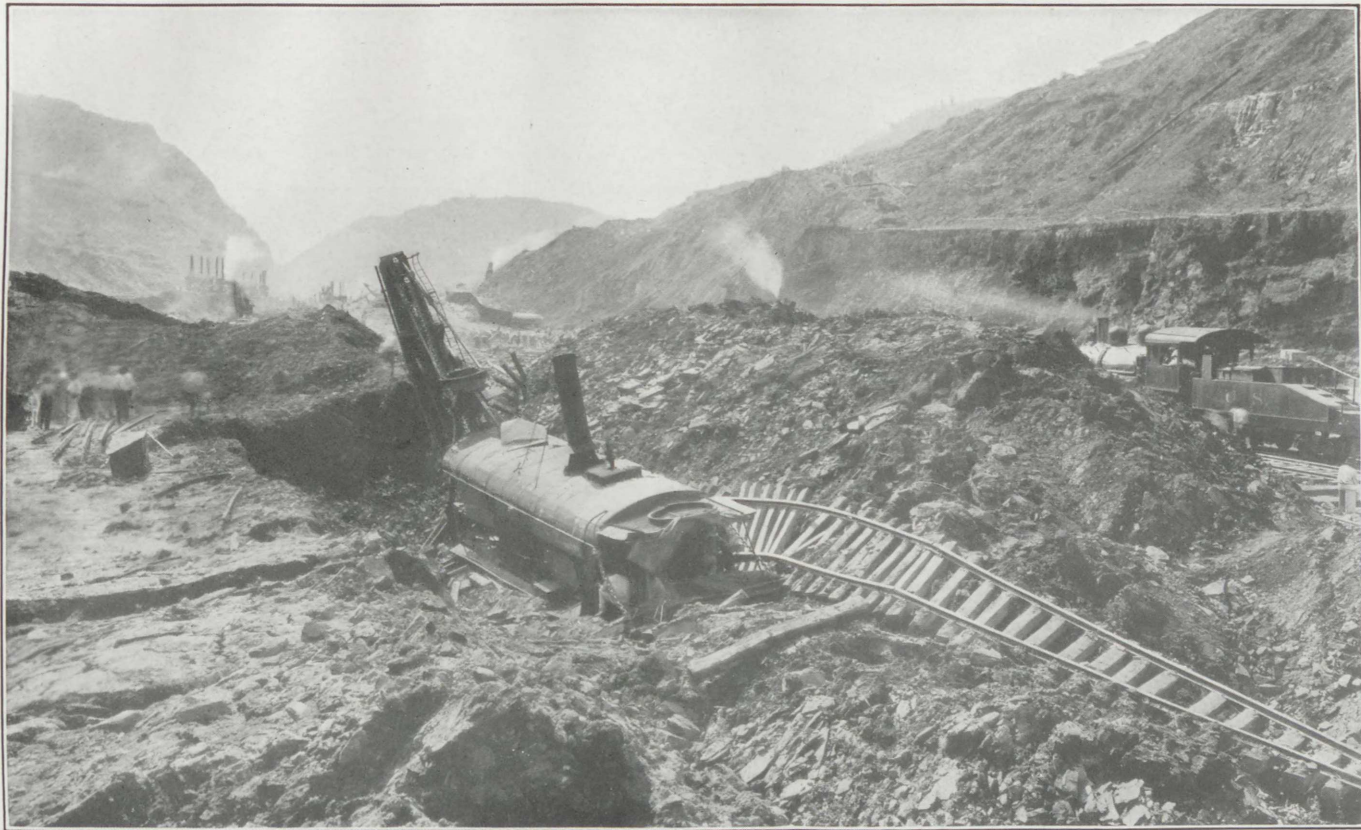
BULGING OF ROCKS IN BOTTOM OF CULEBRA CUT, CULEBRA, IN FRONT OF LARGE BREAK OR DEFORMATION SLIDE IN EAST BANK BETWEEN STATIONS 1746 TO 1758.

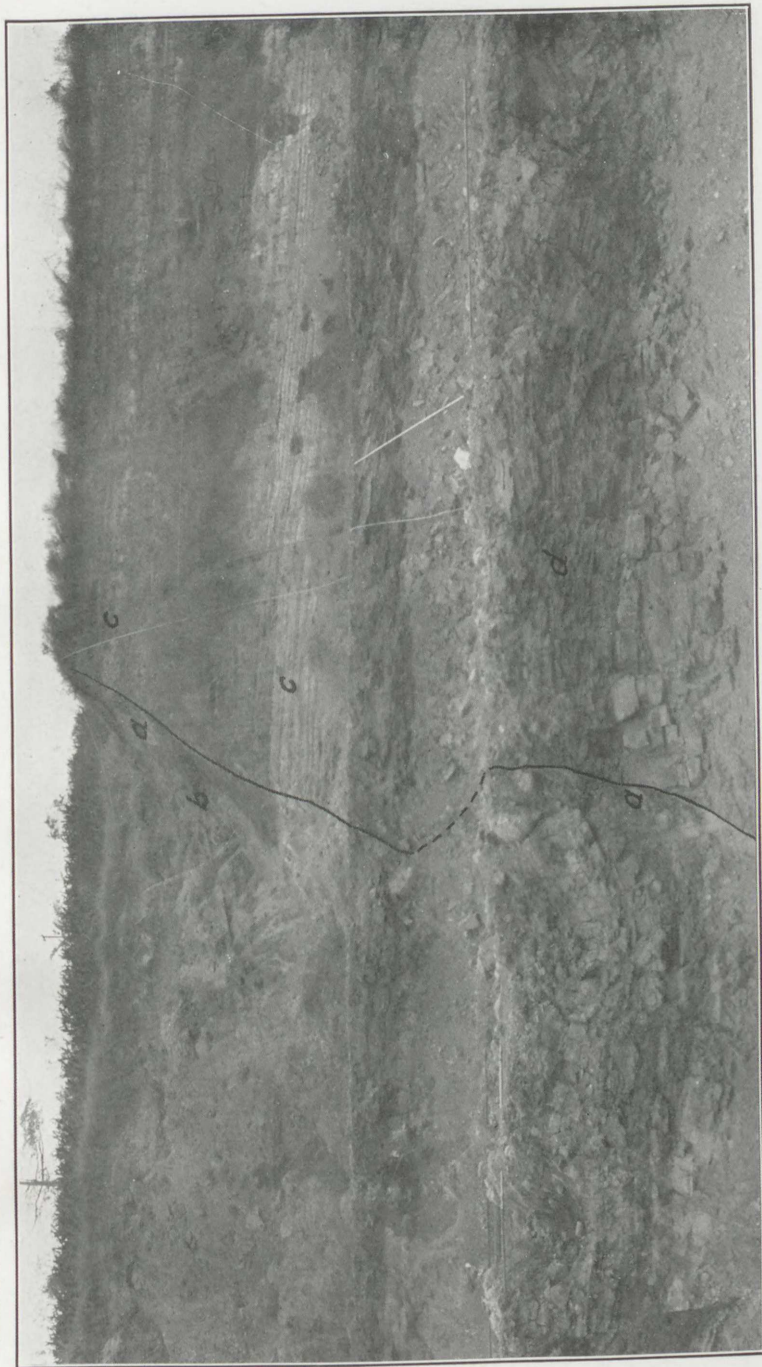
FAULT ZONE NEAR CULEBRA.

a, Fault plane cutting across canal. *b*, Zone of weakened sheared rocks. *c*, Limy sandstone beds which are stronger than the dark carbonaceous clay beds under them (see Plate XV, 1*b*). *d*, Dark carbonaceous clays and bedded tuff (Plate XV, 1*b*). Note how rocks on left of (*b*)—the overhang of the fault plane—have slid into the Cut.

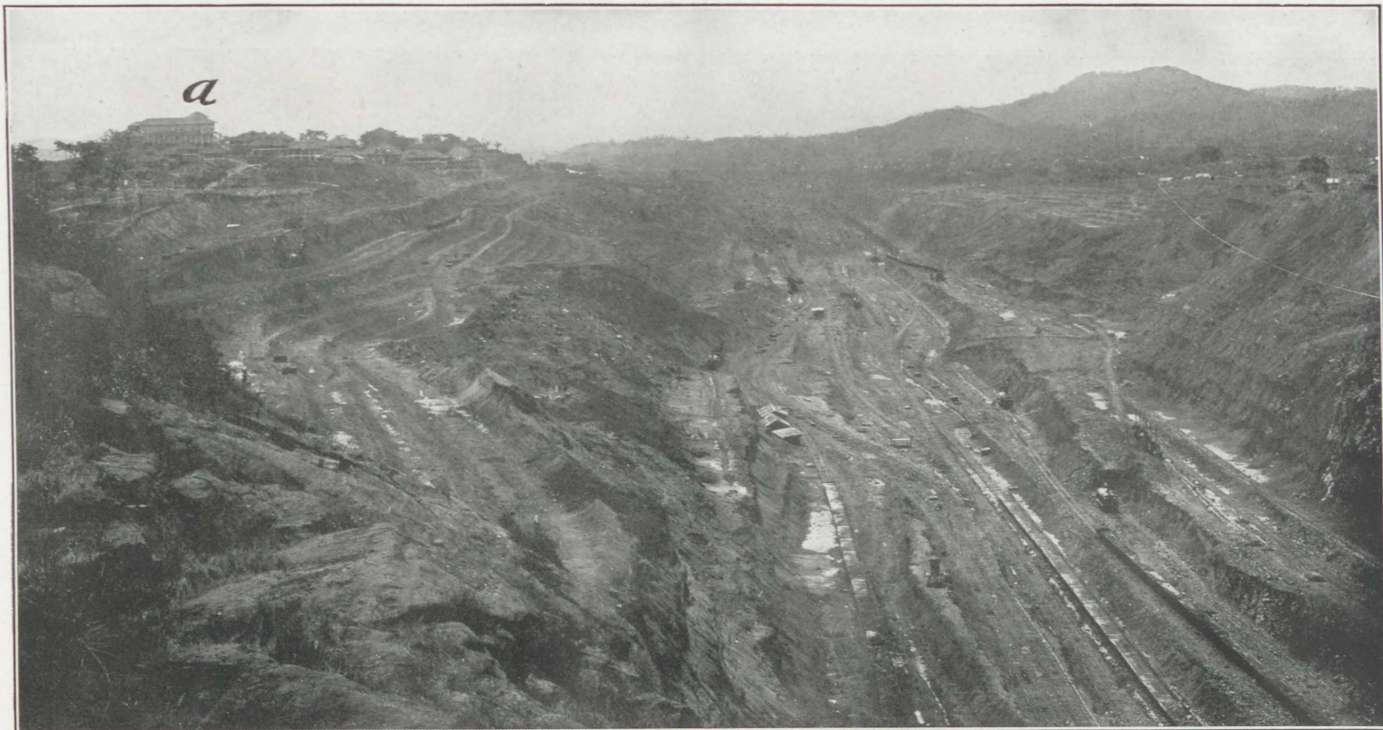
TERRACING ON BOTH SIDES OF CULEBRA CUT, NEAR CULEBRA, TO RELIEVE STRAINED CONDITION OF THE SLOPES. VIEW TAKEN FROM CONTRACTORS HILL, LOOKING NORTH.

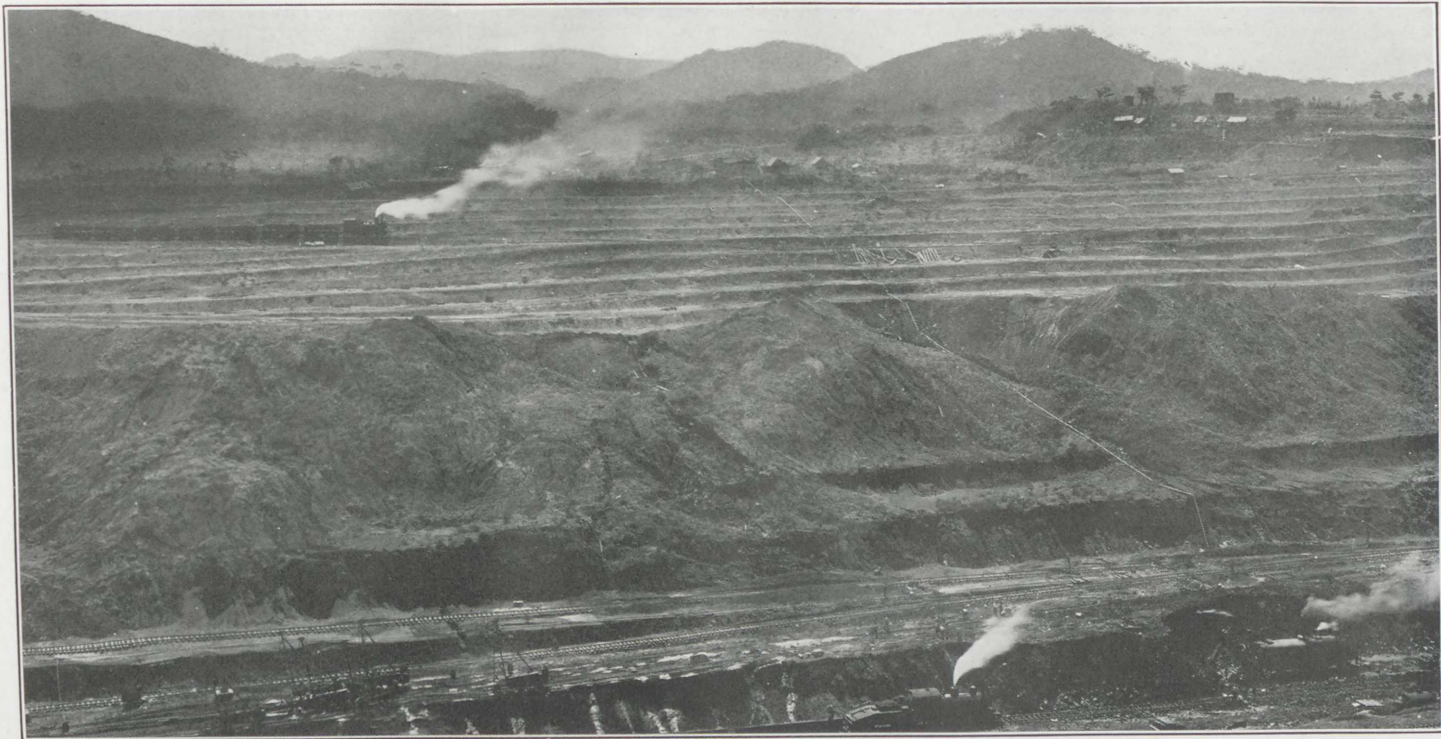
TERRACING TO RELIEVE STRAINED CONDITIONS OF SLOPES, EAST SIDE OF CULEBRA CUT, STATIONS 1735 TO 1765.

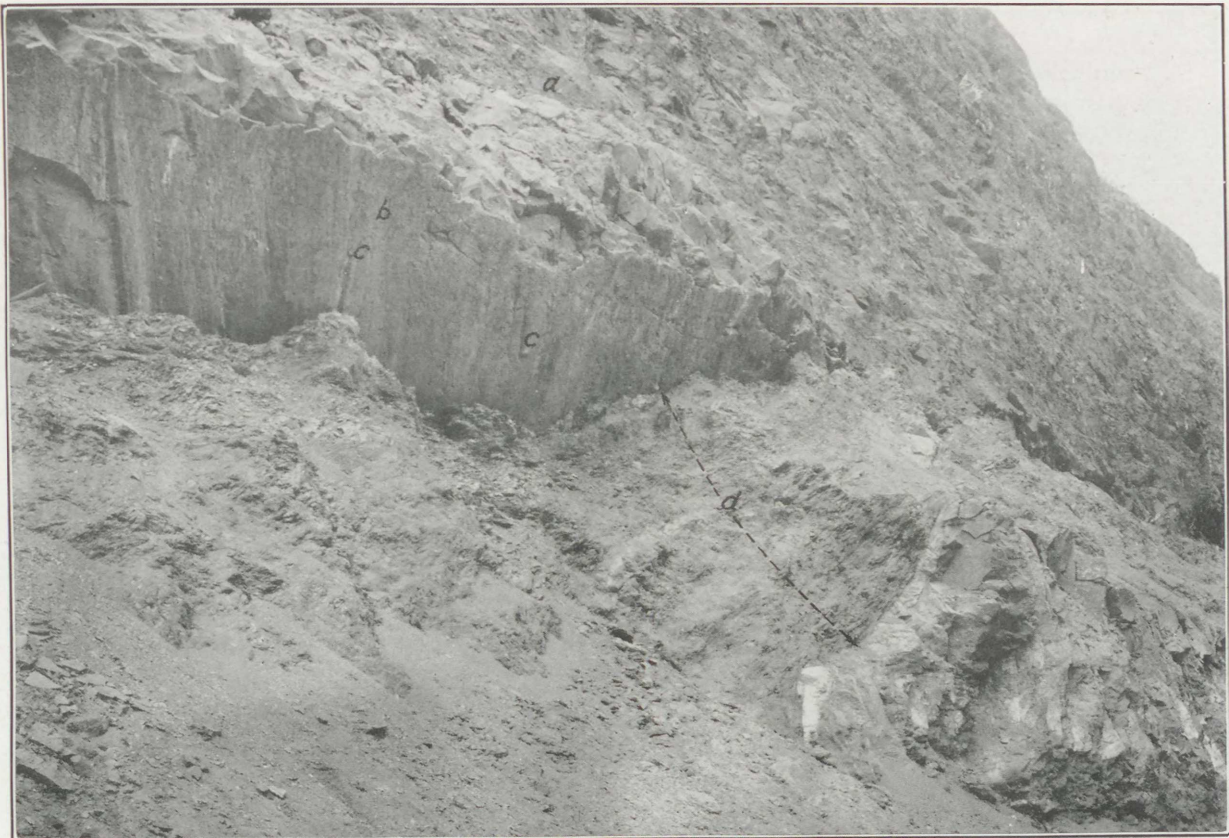
FAULT PLANE AT CONTRACTORS HILL.

a, Contractors Hill mass, which seems to be surrounded by the fault plane *b*. The motion of the hill mass was downward, as shown by the protected little areas of softer matrix behind (above) the hard basaltic fragments in the hill mass, as shown at *c*. The sheared zone *d* is here over 10 feet wide.

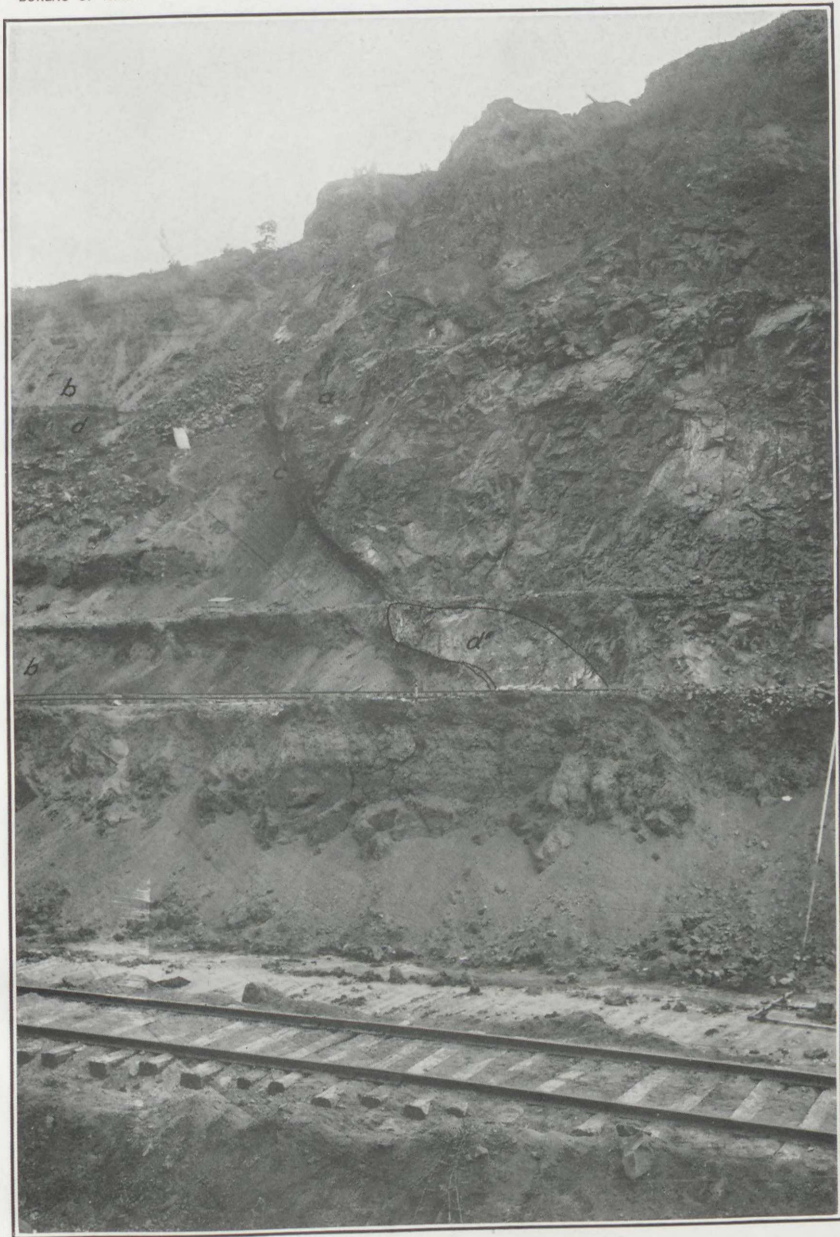
FAULT PLANE AT GOLD HILL.

a, Northerly edge of Gold Hill mass, part of the basalt dike which forms the northern and western periphery of this hill; *b*, Cucuracha formation; *c*, fault zone, which extends around hill mass. *d*, old lava flow; *d'*, mass of old lava pulled down from *d* (over 100 feet) by frictional drag of hill mass, as it was faulted downward in late geologic times.

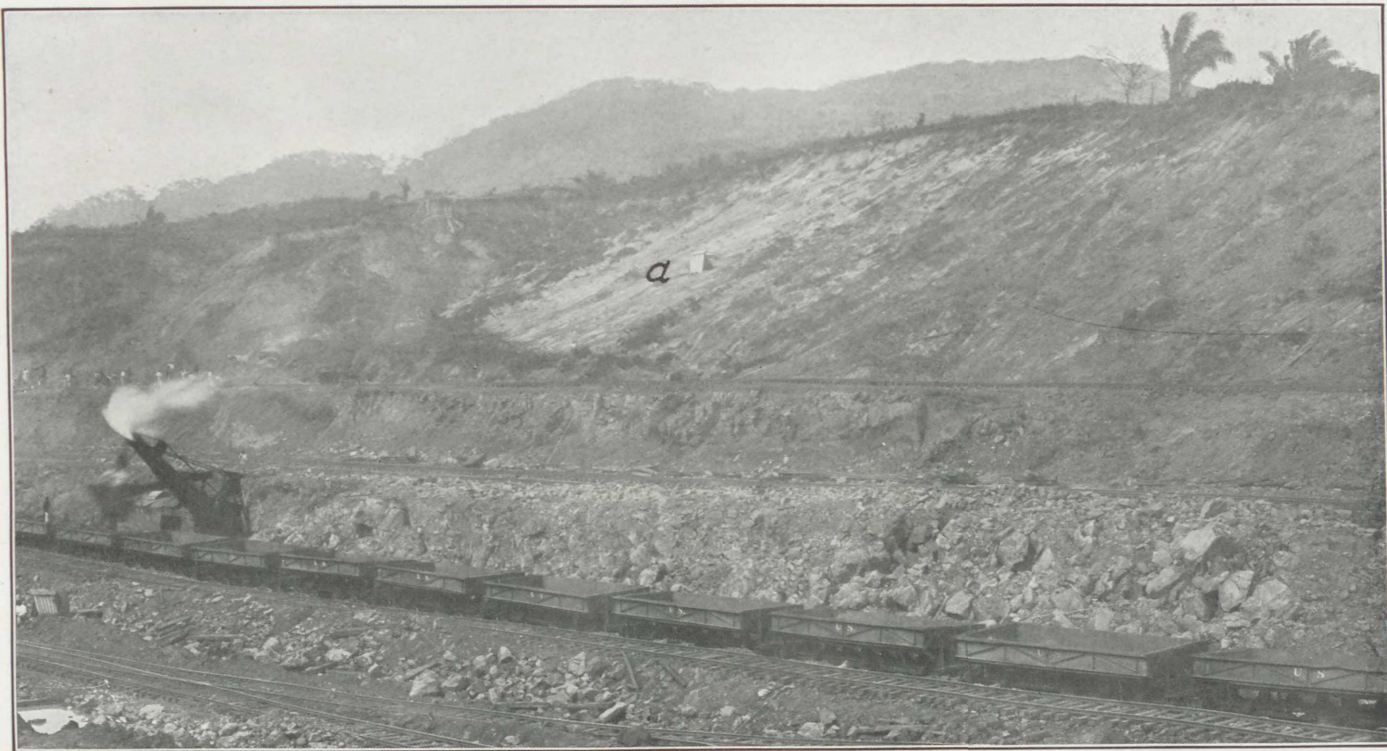
SLIDE NEARLY OPPOSITE LAS CASCADAS, ACTIVE IN 1908 AND 1909.

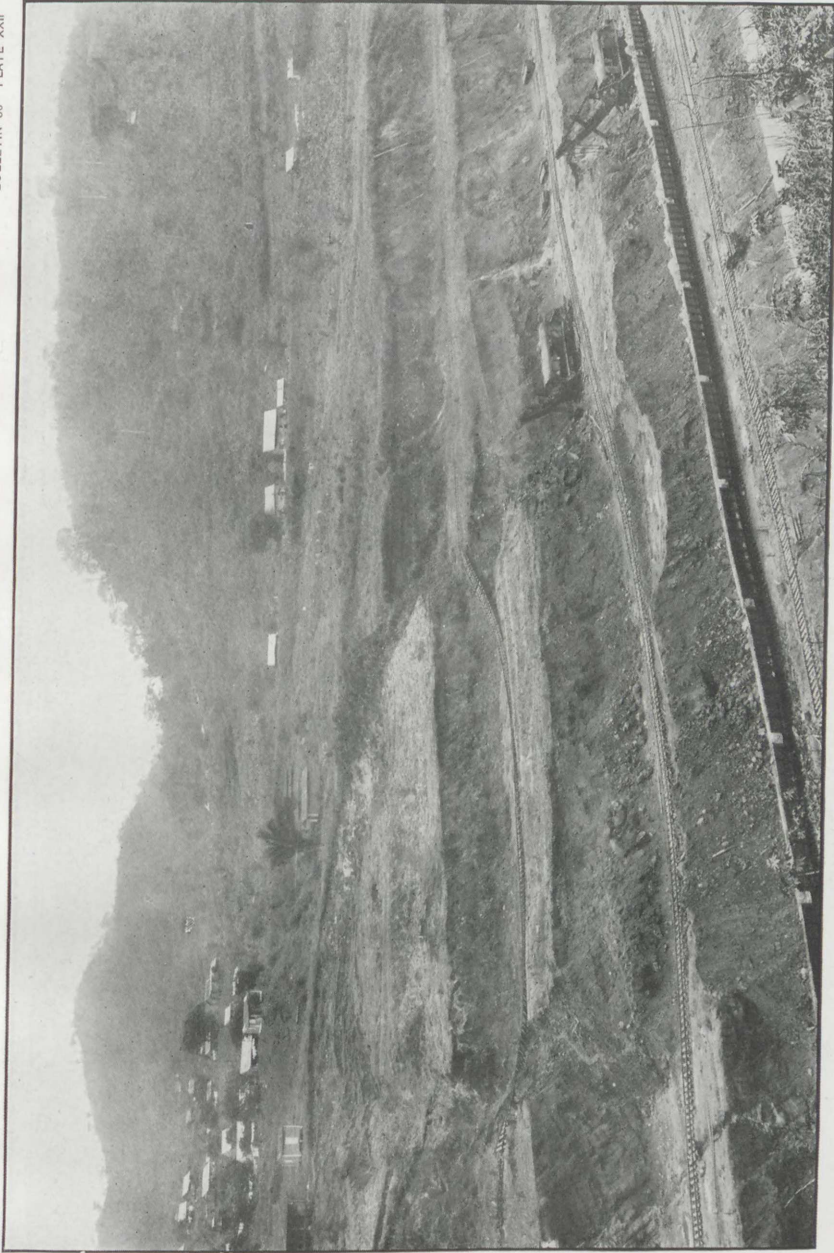
SLIDE NEAR CUCURACHA VILLAGE, EAST SIDE OF CULEBRA CUT.

Slide included 231,000 cubic yards.

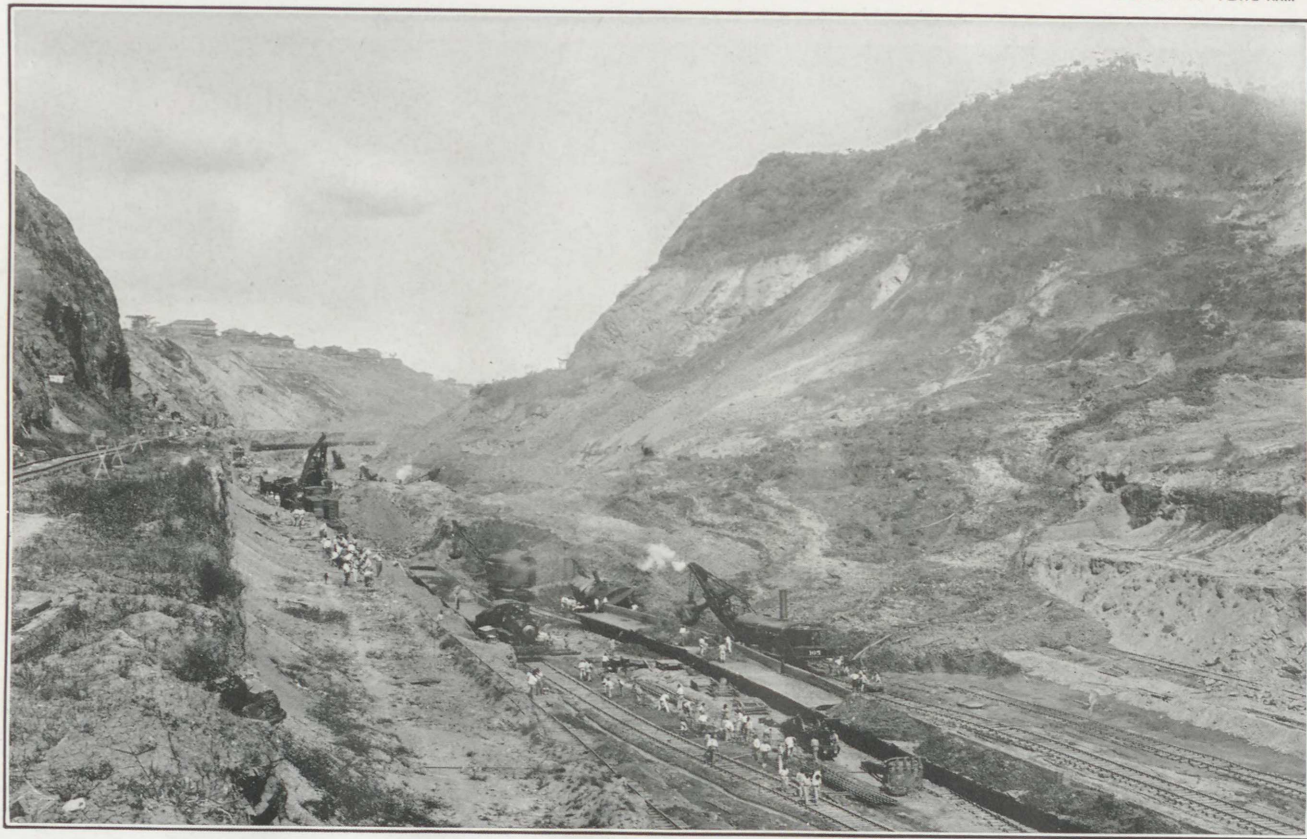
CUCURACHA SLIDE, LOOKING NORTH FROM WEST BANK, SOUTH OF CONTRACTORS HILL, FEBRUARY 7, 1913. NOTE STEAM SHOVEL TILTED OVER BY SLIDE.

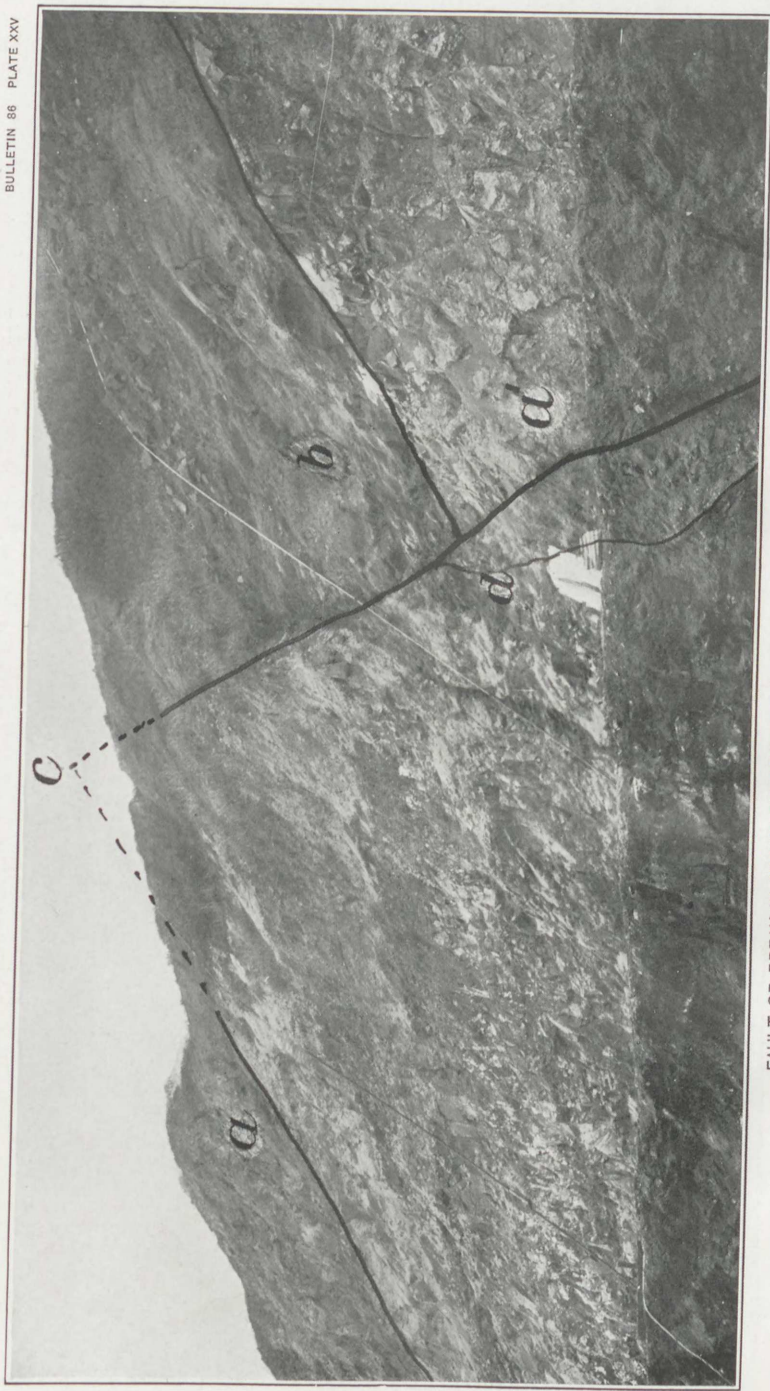
FAULT OR BREAK IN ROCKS ON WEST SIDE OF CULEBRA CUT NEAR STATION 1652.

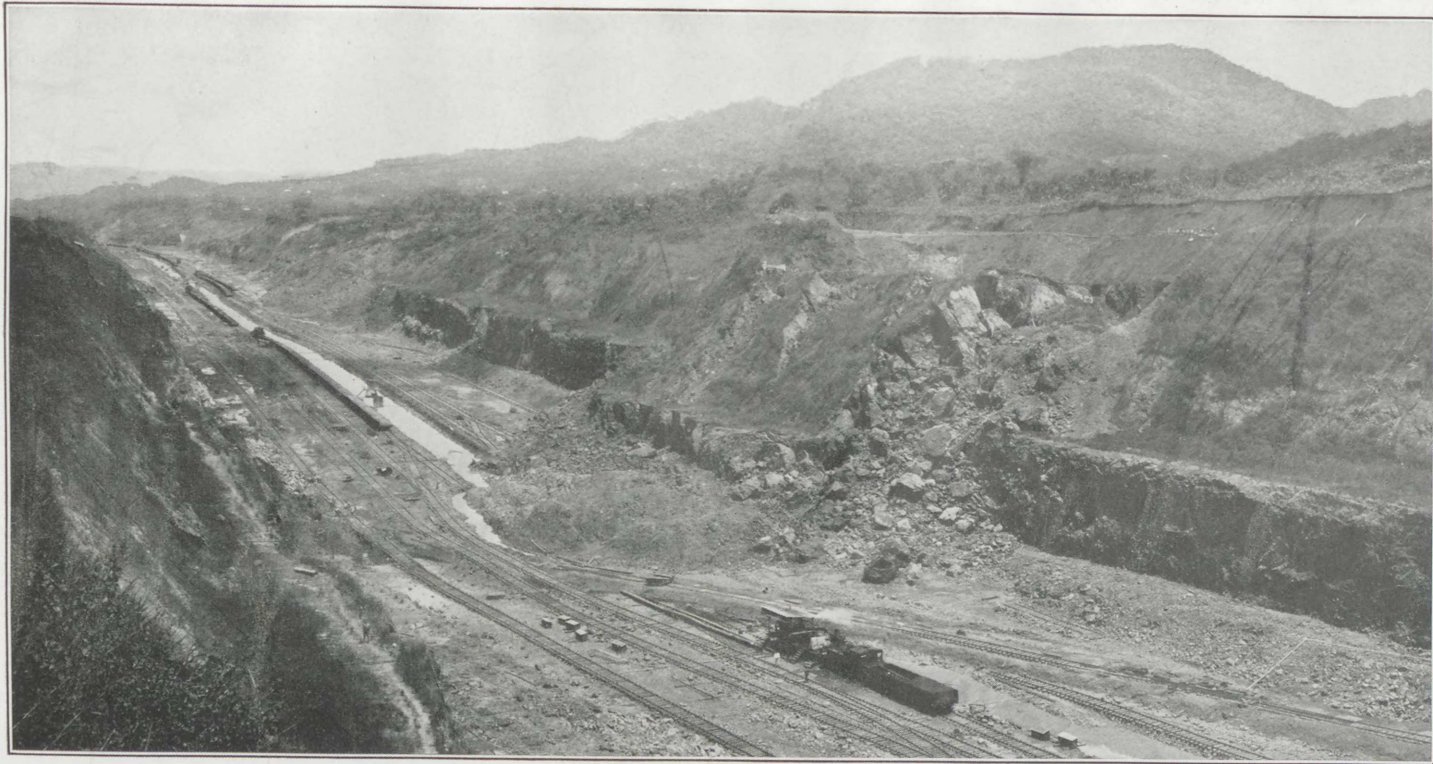
SLIDE ON EAST SIDE OF CULEBRA CUT, NEAR STATION 1652. INCLUDED NEARLY 300,000 CUBIC YARDS OF ROCK. CAUSED LARGELY BY WEAKENING EFFECTS OF FAULT SHOWN IN PLATE XXV.

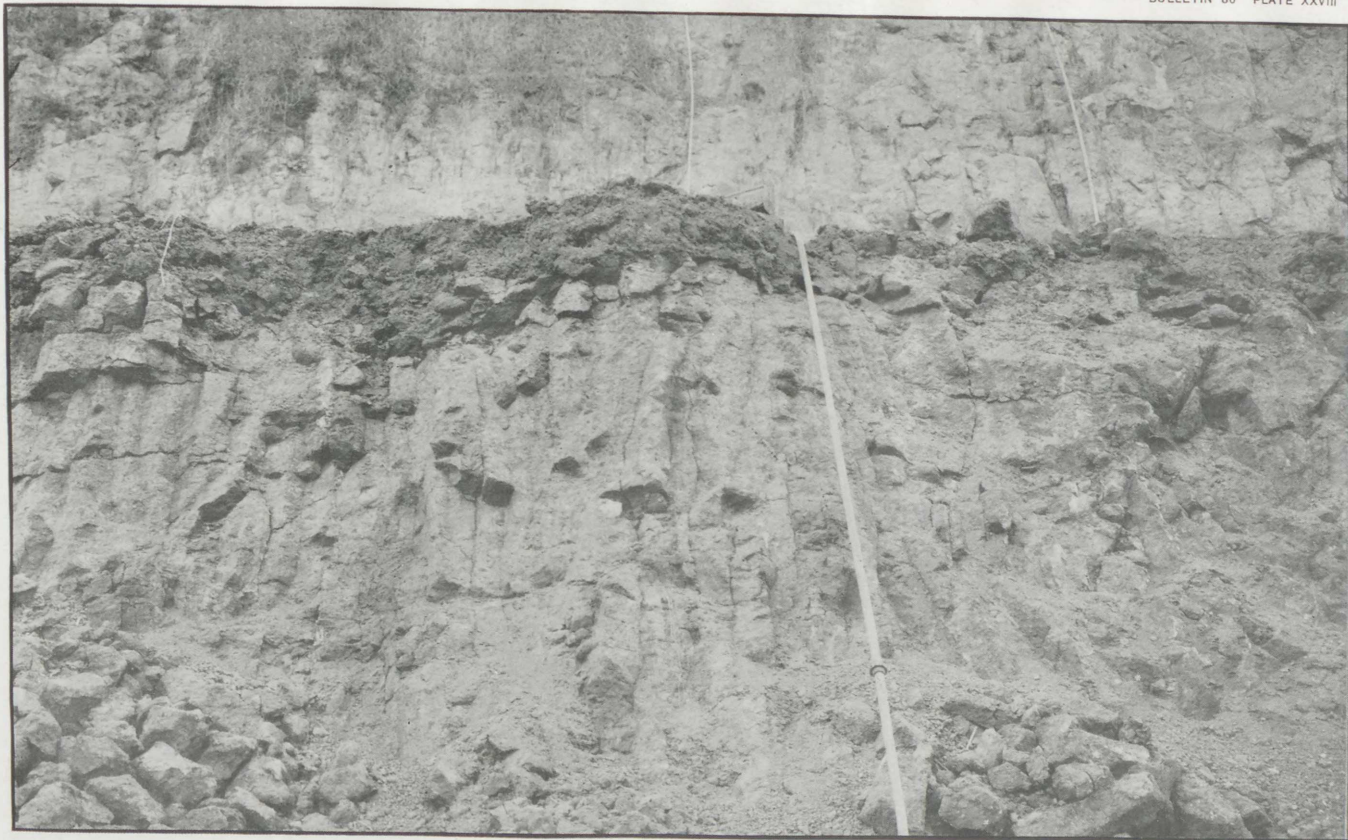
COLUMNAR STRUCTURE IN HARDENED FLOWS OF MUD-LAVA. THIS JOINTING AFFORDED PASSAGES FOR SEEPAGE WATER FROM THE OBISPO DIVERSION AND FROM GROUND WATER WHICH SOFTENED THE BASAL MASS, ALREADY UNDER HIGH PRESSURE, AND THUS TENDED TO PROMOTE THE LARGE SLIDE AT STATION 1652 SHOWN IN PLATE XXVI.

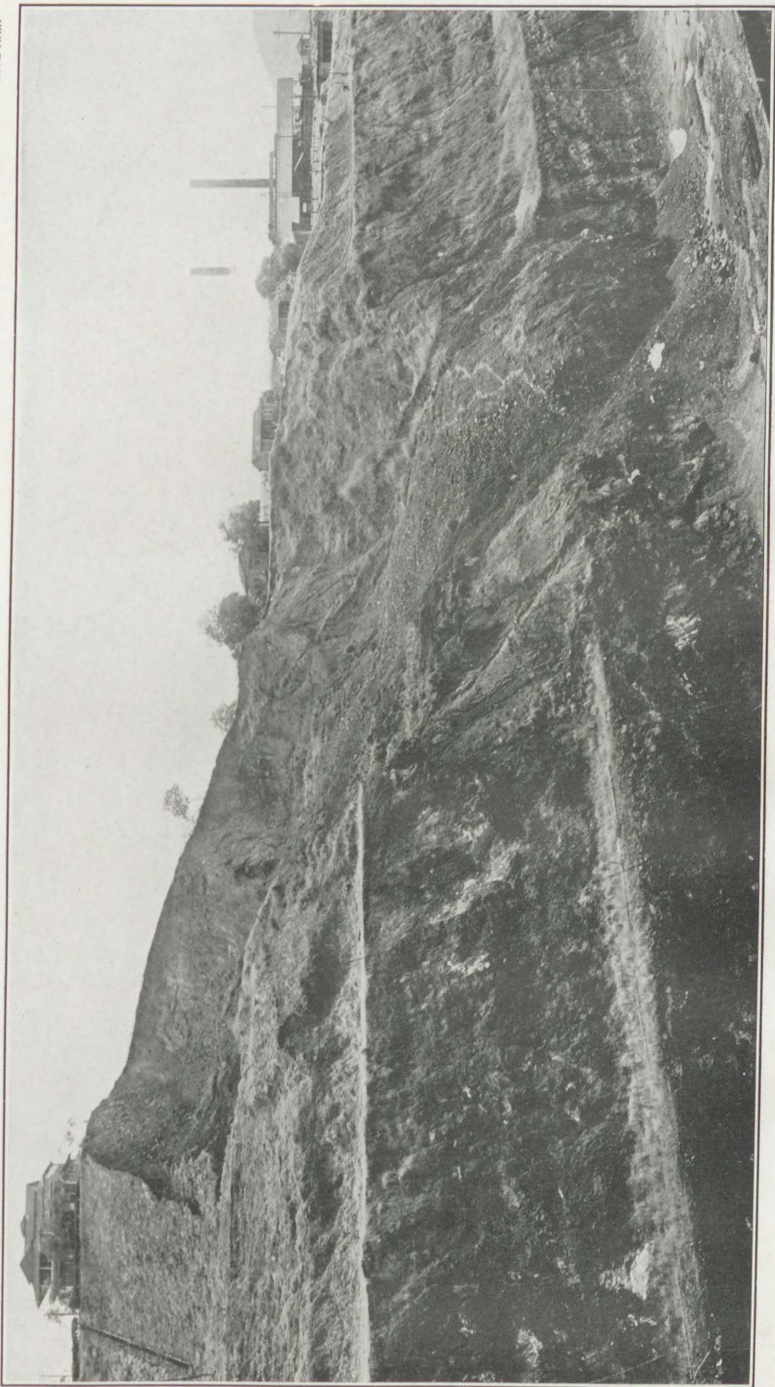
SLIDE NEAR DIVISION OFFICE, THE BUILDING ON THE LEFT, EMPIRE.
