SOME ENGINEERING PROBLEMS OF THE PANAMA
CANAL IN THEIR RELATION TO GEOLOGY
AND TOPOGRAPHY

DONALD F. MACDONALD

WASHINGTON
GOVERNMENT PRINTING OFFICE
1915

Bulletin 86

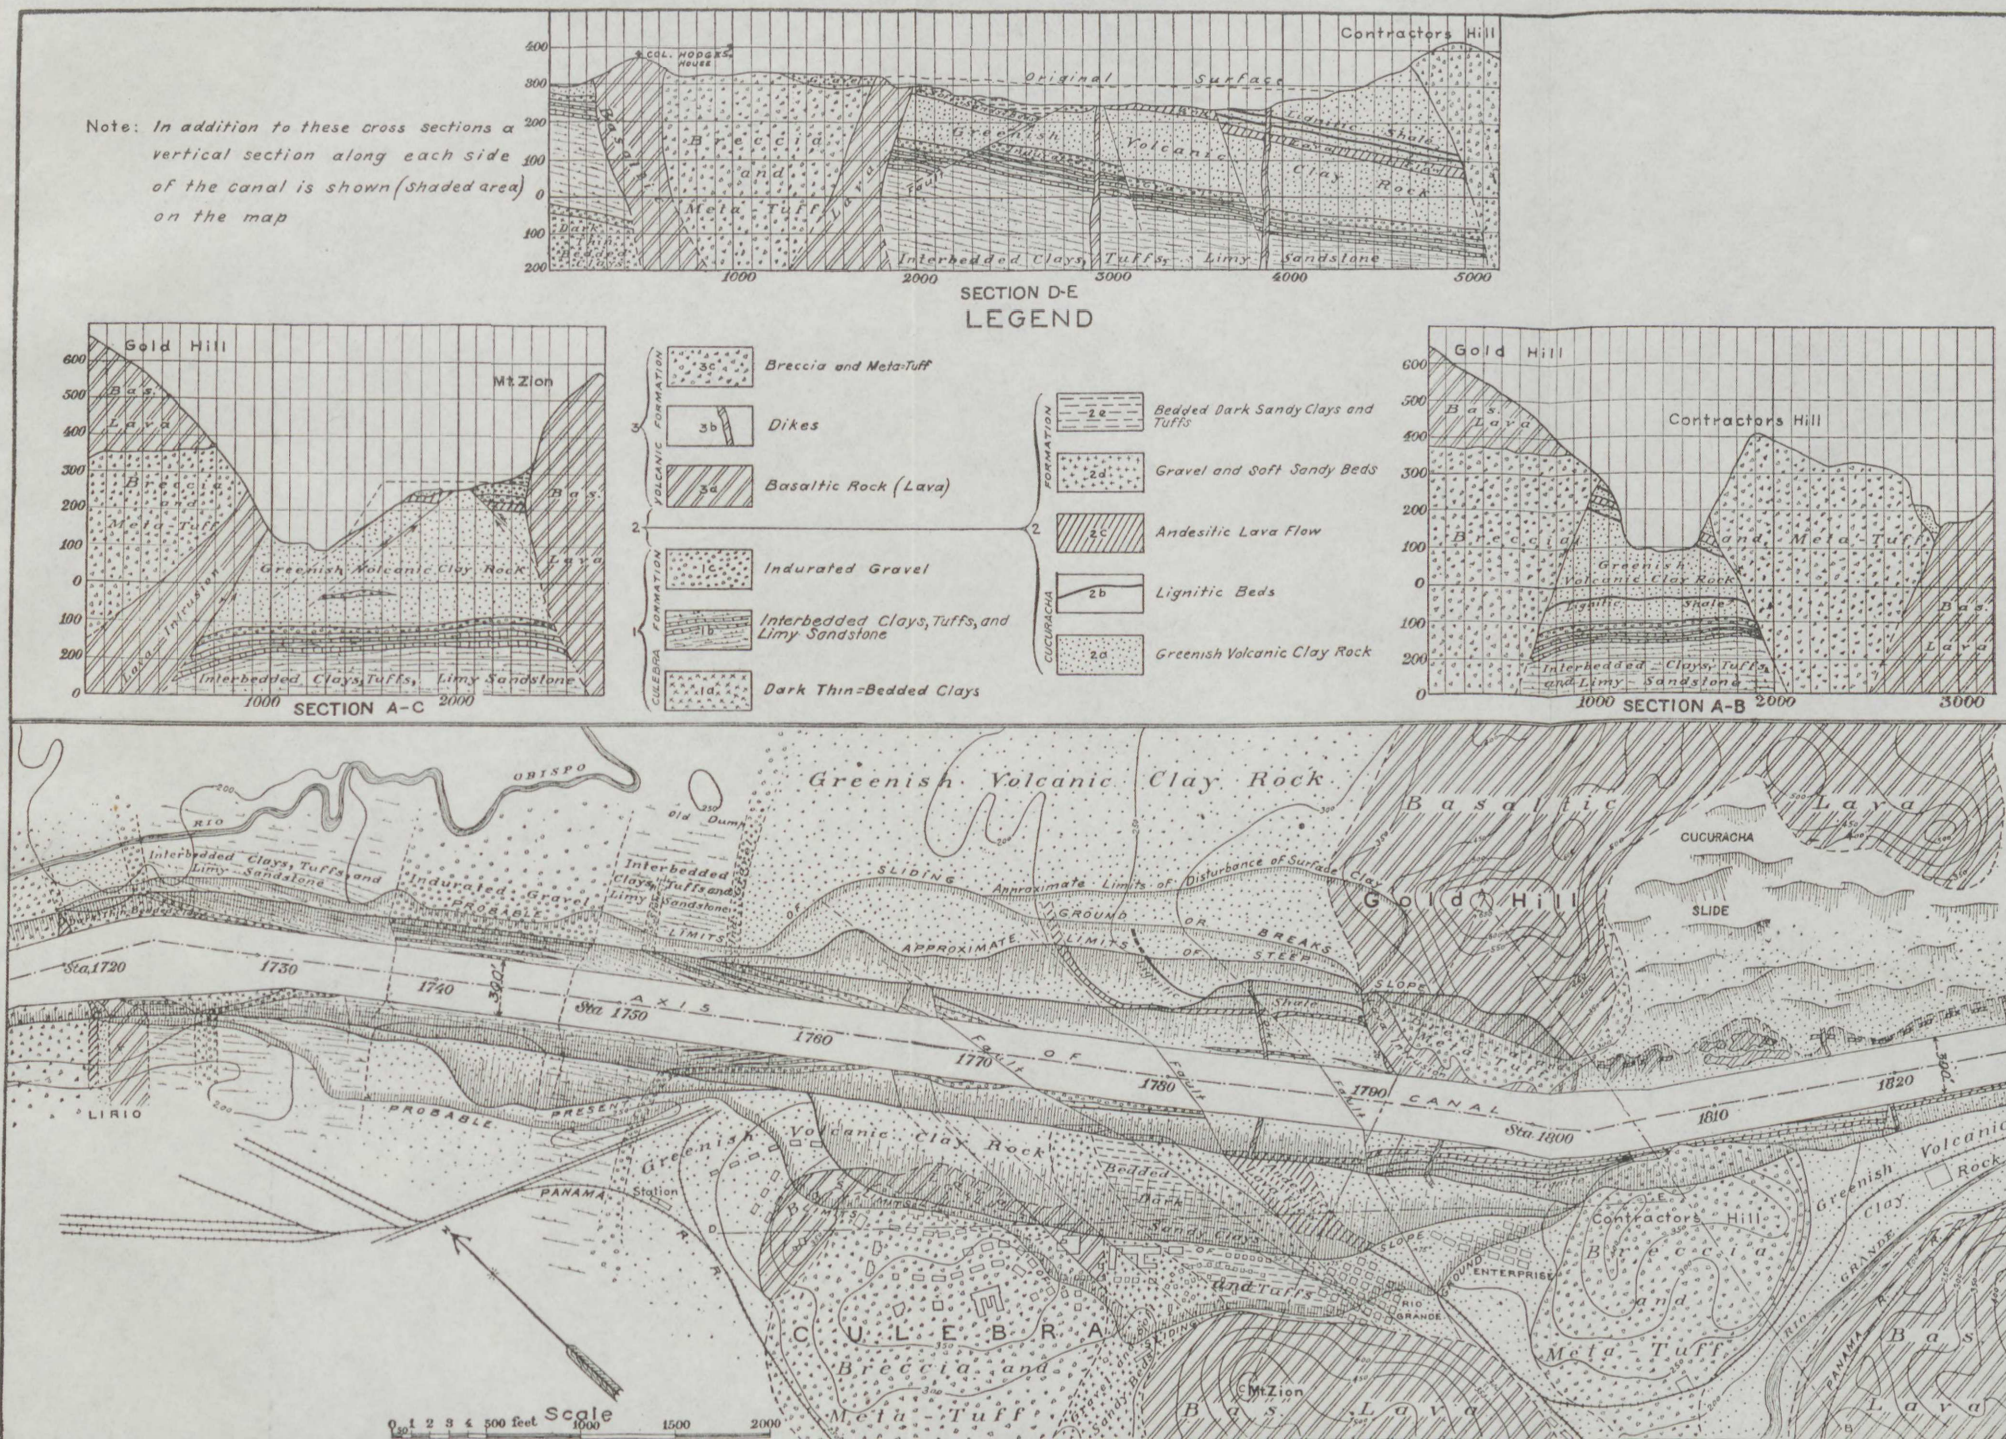
MAP AND SECTIONS TO SHOW GEOLOGIC CONDITIONS AND PROBABLE LIMITS OF SLIDING GROUND, CULEBRA AND VICINITY.

places these limits may not be reached. On the whole, however, it is believed that these lines represent pretty closely the area of ground that is likely to be disturbed. This area may be narrowed down somewhat by the relieving excavation work which may be completed, say, before the close of the next dry season. It will be noted that these lines converge on the cut about station 1760, and are comparatively restricted for the next 1,000 feet northward. This is due to the strengthening effects of the sandy limestone and limy sandstone beds that occur toward the surface there. The western slope in the vicinity of 1740 to 1745 will probably be disturbed to a rather wide extent, but the sliding there will be somewhat superficial, and large movements of the break type should not occur. These superficial slides are due largely to the presence of the lens of greenish, sandy clay rock shown on Plate XV. The upper part of this becomes muddy, and any material that may overlie it easily slips into the cut.

In spite of much subsequent deepening of Culebra Cut with some flattening of its slopes, the "probable limits of sliding ground" shown on Plate XV (made in 1911) hold good, with some exceptions, at the date of writing, August, 1915. In a memorandum to the Chairman and Chief Engineer of the Isthmian Canal Commission, dated May 10, 1913, the writer predicted a serious slide just north of Gold Hill, the outer limits of which would be at some cracks 1,500 feet back from the center of the canal. This slide will be far outside the limiting line mentioned above. A somewhat unlooked-for slide on the east side of the cut, between stations 1746 and 1758 in February, 1913, was caused by two large fault zones which were masked by sloughing material so that their dangerous character was hidden until the slide came down.

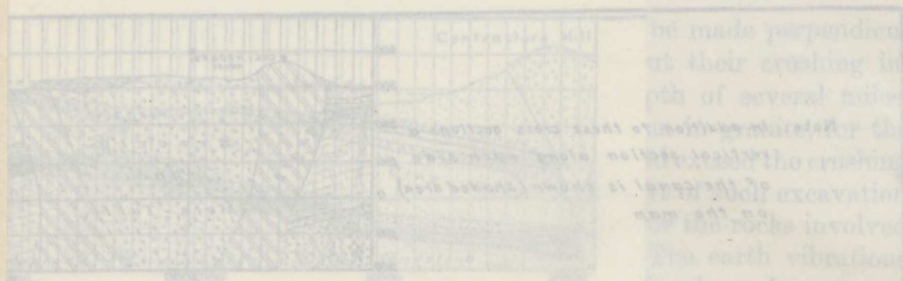
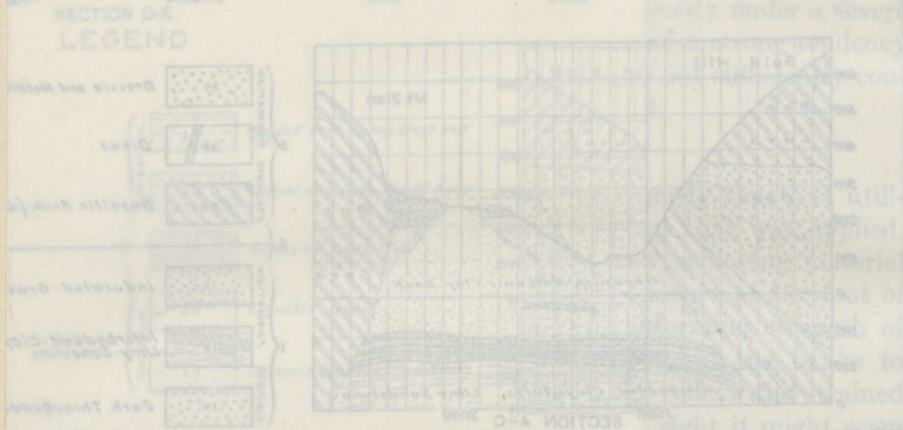
MAP AND SECTIONS TO SHOW GEOLOGIC CONDITIONS

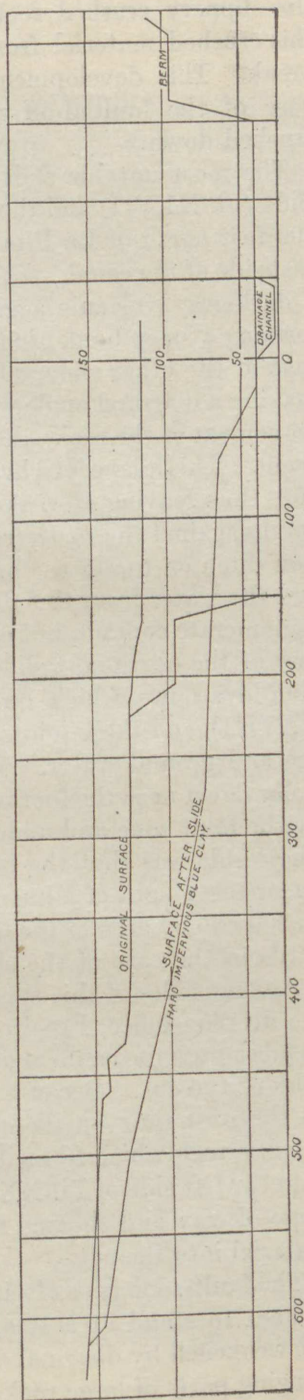
The third type of slide was that occasioned primarily by sheared and weakened zones in the rocks, due to fault displacements. As the rock masses moved past each other, in the adjustment of earth blocks in late geologic time, the frictional pressure or drag was often great enough to crush and shear the material for several feet on each side of the plane of movement (Pls. XV, XIX, XX, and XXV). Where faults of this kind cut diagonally across the canal large masses of rock in the acute angle between the fault plane and the plane of the canal slope generally fell out into the excavation. Where the fault plane had a considerable dip it left a mass of rock, with a narrow base and wide top, resting insecurely against

FIGURE 9.—Cross section of slide shown in Plate XXII.

the slippery crushed rock of the fault zone and quite separated by this crushed material from the solid rock on the other side of the break. This development, of course, threw an extra strain on the base of the faulted-off mass, and if that failed, the whole block crushed down.

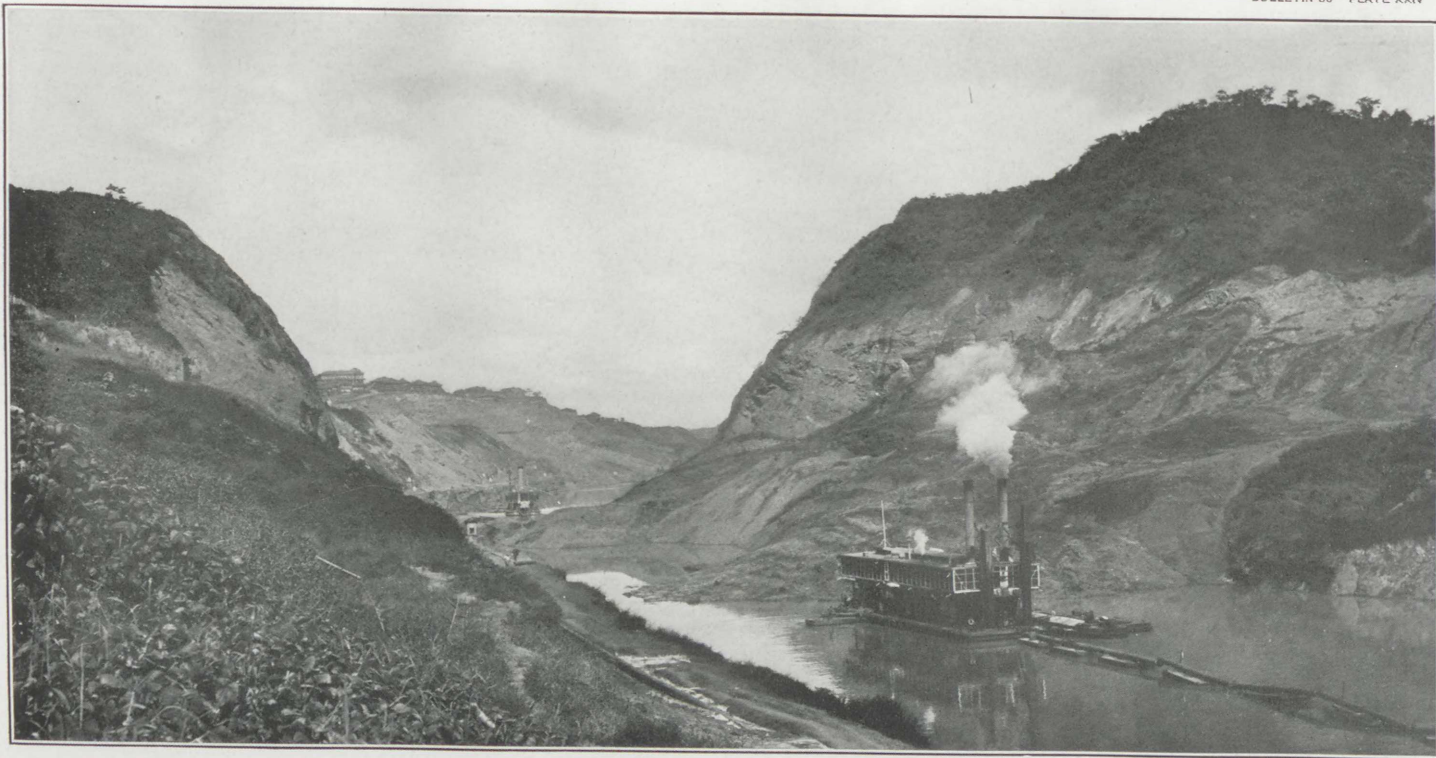
DREDGES WORKING ON CUCURACHA SLIDE AFTER THE WATERS HAD BEEN TURNED INTO CULEBRA CUT.
