# KALLUNDBORG CHURCH

BY  
MOGENS CLEMMENSEN  
AND  
VILH. LORENZEN

# KALLUNDBORG KIRKE

AF  
MOGENS CLEMMENSEN  
OG  
VILH. LORENZEN

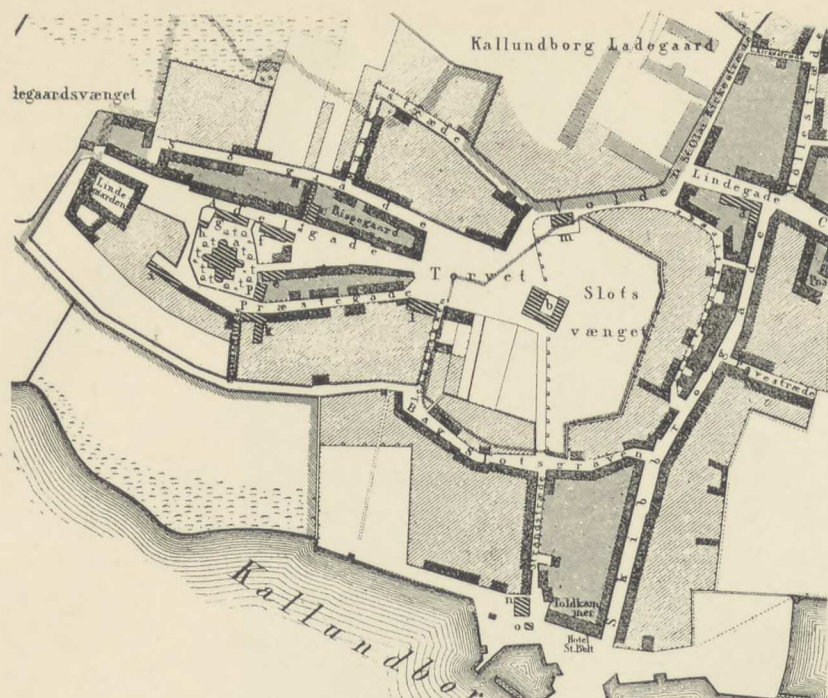
Fig. 4. Kallundborg Øvreby 1860. — Kallundborg Upper Town 1860.

Kallundborg By breder sig langs Fjordens nordlige Bred og bestaar af to Dele, omtrentlig lige store i Udstrækning Vest—Øst. Den østlige Dels Bebyggelse er i alt væsentligt bestemt af en lang Hovedgade, der nøje følger Foden af et Højdeplateau — Møllebakken — og er en Fortsættelse af den gamle Landevej, der fra Holbæk stiler mod det gamle Overfartssted. Over den lavtliggende Bydel, Nederbyen, løfter det skovklædte Bakkehæld sig højt og friskt og danner den lune Baggrund for Husenes Rækker og Klynger. Den vestlige Del, Øvrebyen, ligger paa en langagtig Bakke, mod Nord og Vest begrænset af lave Engstrækninger — Munkeengen — og mod Syd af Fjordens Vande (Fig. 4).

Kallundborg city, stretching along the north shore of the fjord, is divided into two parts which spread equally toward east and west. The building on the east is largely determined by a long main street which closely follows the contours of the base of a plateau — Møllebakken (Mill Hill), — and is a continuance of the ancient roadway leading from Holbaek to the ferry. Above this lowlying section, the lower town, the woody slopes of the hill rise, high and fresh, forming a warm shelter for the rows and groups of houses. The western section, the upper town, follows a terrace fringed on the north and west by low meadow-lands, — the Munke-eng (Monk Meadow), — and on the south by the waters of the fjord (Fig. 4).

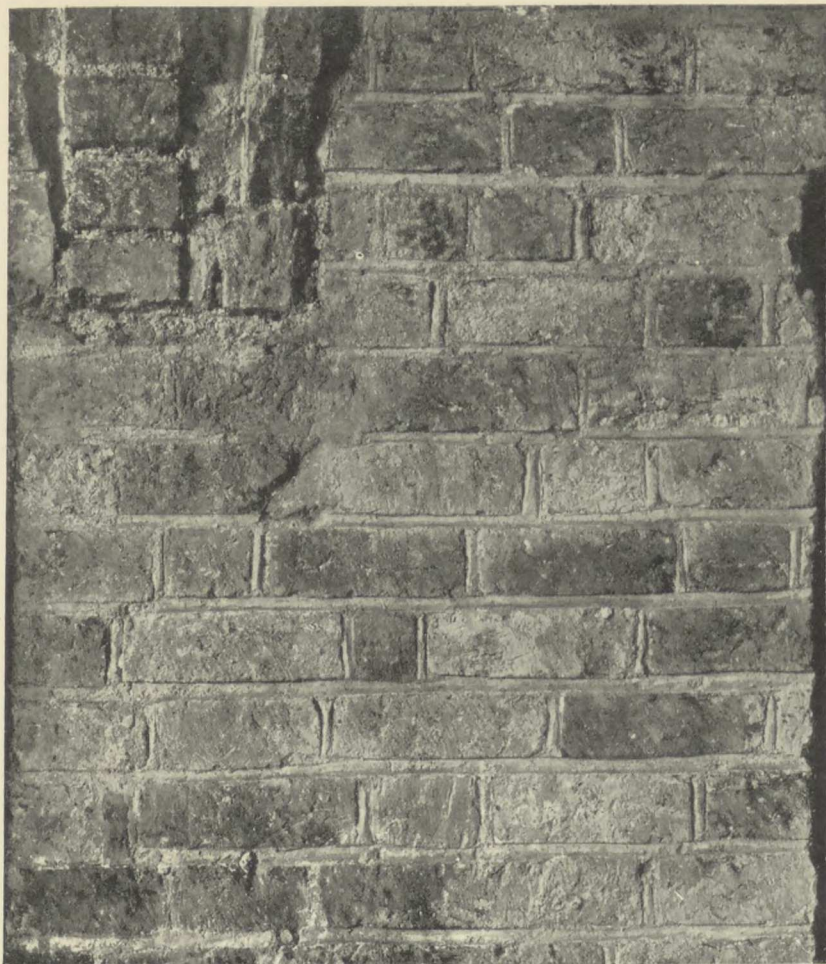
Fig. 8. Oprindeligt Murværk. — Original masonry.

25—26 × 13 × 8—8½ cm. Hovedparten af Stenene maaler dog 28—30 × 13—14 × 8½ cm, Gennemsnitsmaalet for Mursten i vore romanske Teglstenskirker. Ved alle Hjørner og paa alle Formsten er Murstenenes Yderside riffelhugget *efter* Brændingen, med Rifflerne i Reglen gaaende fra venstre skraat ned ad til højre som det falder naturligt, naar man ved Hugningen holder Stenen i venstre Haand og Hammeren med højre. Denne Riffelhugning er som bekendt karakteristisk for vor ældste Teglstensarkitektur og bliver omkring Midten af 13de Aarh. anbragt paa Stenen *for* Brændingen, for kort efter helt at gaa af Mode. — Mørtelen er ganske fortrinlig og nu af en saadan Haardhed, at Kalk og Mursten virker som en ensartet haard Masse; den er ret fed, iblandet groft Grus, og nu af en hvidgul Farve, der har gjort det let under Restaureringen at skelne det oprindelige Murværk fra senere Tiders. Fugerne er gennemgaaende tykke, 2—2½ cm, og noget uregelmæssigt ryg-skaarne, som det ses paa Fig. 8, der viser oprindelig *udvendig* Mur, som er bevaret ind mod Sakristiet. Det har ved Undersøgelsen vist sig, at Murværket overalt indvendig, og vistnok ogsaa udvendig, oprindeligt har staaet rødmalet med hvidt optrukne Fuger, som det nu efter Restaureringen er synligt mange Steder, og som der senere skal gøres Rede for ved Beskrivelsen af Kirkens Indre. Metoden viser sig at have været ikke ualmindelig i vore romanske Teglstenskirker, og er saaledes ikke noget enestaaende for Kallundborg Kirke<sup>2</sup>.

ners and at all the mould-bricks, the outer surface of the bricks is fluted *after* firing, with the flutings, as a rule, going obliquely from left to right, the natural direction, when in cutting the brick is held in the left hand and the mallet in the right. This fluting, as is well-known, is very characteristic of the oldest Danish brick architecture, and, about the middle of the 13th century, was placed on the bricks *before* firing; by degrees it has passed out of fashion. The mortar used is of excellent quality, and is so hard that lime and brick form a uniform solid mass; as it is now of a whitish yellow color and quite heavy, mixed as it is with coarse sand, it has been a simple matter under restoration to distinguish the original masonry from that of later periods. The joints are usually thick, 2—2½ cm and cut rather irregularly in ridges, as seen in Fig. 8, showing the original external wall, which has been preserved toward the sacristy. Investigations have shown that the walls everywhere on the inside, and presumably also on the outside, have been colored red with the joints whitened, which after restoration were visible in many places. Later, in our description of the interior of the church, we will return to this point. The method is not unusual in Danish Romanesque brick churches and is by no means an unique feature of Kallundborg Church<sup>2</sup>.

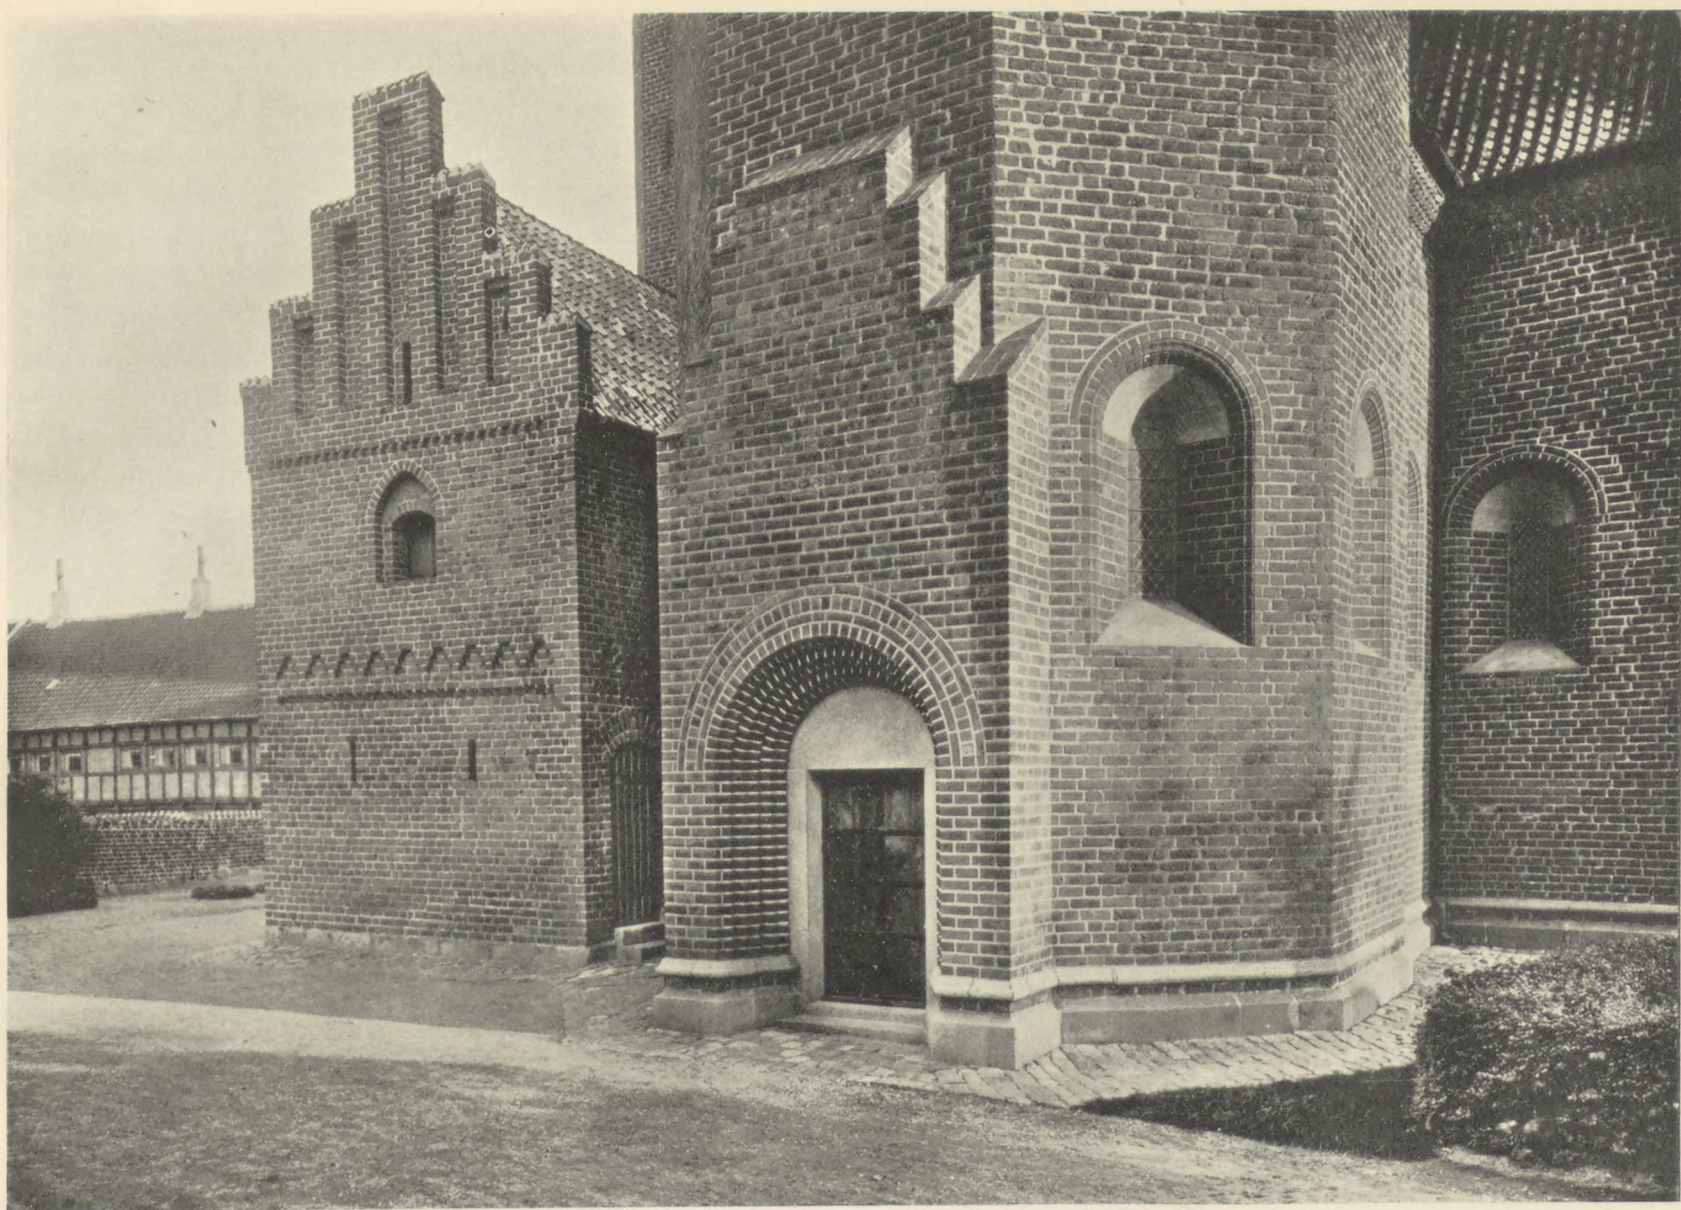
Fig. 10. Nordportal og Gavlf af Sakristi. — Northern entrance and gable of sacristy.

Nordportalen (P. VIII og Fig. 10) er paa de ældre Opmaalingssplaner vist med et ret stort Fremspring fra Taarnmuren, og alt tyder paa, at det er den oprindelige Portal man har bortrugget ved Restaureringen i 1870. Ved at fjerne alt nyere Murværk saa man de friske Brud af det borthuggede Fremspring, hvis Sidelinjer tydeligt kunde følges; endvidere fandtes i Jorden det oprindelige Kampestensfundament bevaret, ligesom tydelige Aftryk i Murværket af de oprindelige Granitkarmer med Tympanon viste, at Portalens Karmparti havde ligget betydelig

Older drawings (Plate VIII and Fig. 10) show the north entrance to have been in a rather large projection from the wall of the tower. Everything seems to indicate that this entrance, untouched until then, was removed under the restoration in 1870. By removing the new walls the fresh marks from hewing away the projection appeared and the lines of its sides could be plainly traced. In the ground was found the original hard-stone foundation, and in the walls clear marks of the original granite casement with tympanum, all of which proved that the casement of the entrance lay much further forward than it was placed under the restoration in 1870. Older drawings plainly showed the profiles in which an original remaining mould-brick was found in the oldest walls. As according to the older drawings, this was the only form of profile used in this entrance, the projection of the entrance could be exactly determined and corresponds moreover to the foundations. Closer investigations of the original wall above the entrance behind the new shell-wall, revealed various vertical grooves and hewn headers showing that the upper part of the projection was completed by corbel-steps similar to crenellated gothic gables,—all of whose joints could be exactly determined. Under restoration the surfaces of the steps have been given a covering of bricks as it was impossible to determine whether they were covered in this way, with lead, or with tiles. On the inside the entrance has oblique sides and the arch plastered. In the bevels of the sides holes were found for bars<sup>5</sup>.

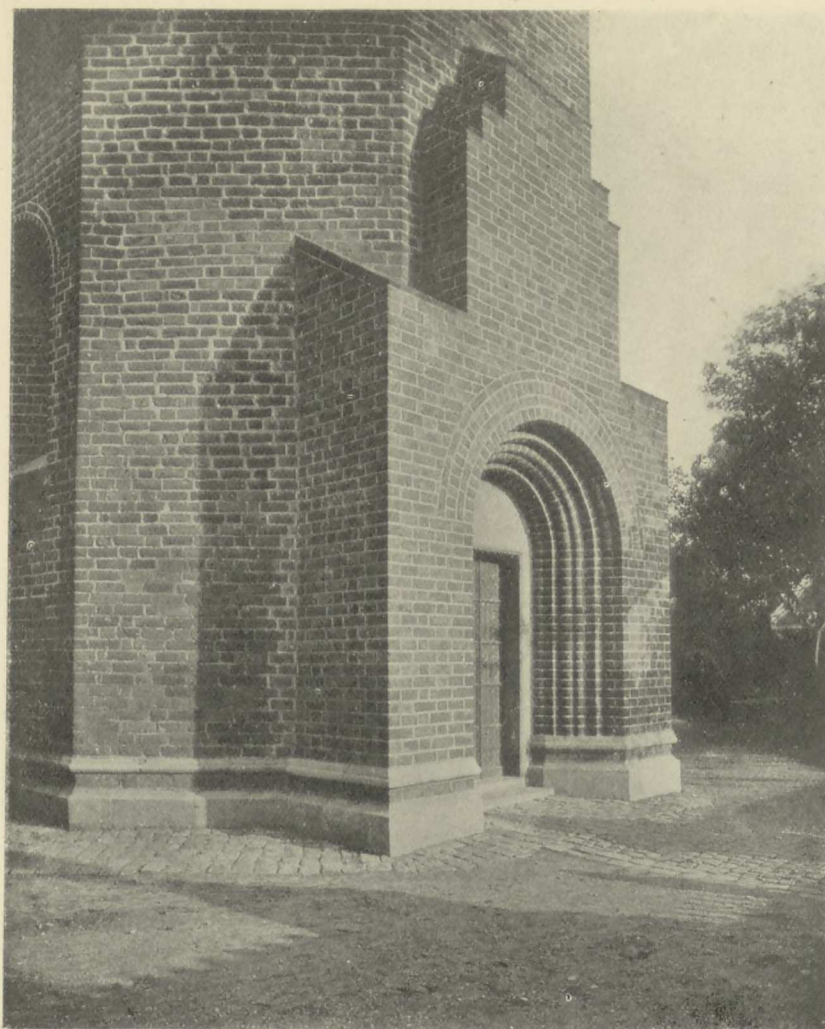
Fig. 11. Vestportal. — Western entrance.

Before the restoration of 1870 the west entrance too, was placed in a projection which was considerably larger than the one on the north transept. However already at that time this had been changed to an entrance in Baroque style, which perhaps made the question of its genuineness doubtful. When the masonry was removed the same conditions were found as at the north entrance. The side lines of the projection, the upper contours and parts of the foundation were preserved in such condition that the entrance could be restored to its original form, which, in the detail of the corbel-steps, differed somewhat from the north entrance (Pl. VIII and Fig. 11). It appeared, moreover, that the granite slabs of the tympanum and the jambs were original, and were embedded undisturbed in their place in the original wall. However, in 1870 the granite seems to have been hewn and the corners bevelled. At this entrance, too, we were fortunate enough to find in the old walls a

For Vestportalens Vedkommende var ogsaa den, førend den i 1870 blev ombygget, anbragt i et Fremspring, der har været en Del større end ved Nordportalen; den var imidlertid allerede dengang omdannet til en Barokportal, hvad der muligvis har givet Anledning til Tvivl om dens Oprindelighed. Forholdene var, efter at alt nyere Murværk blev fjernet, ganske som ved Nordportalen; Fremspringets Sidelinjer, Konturer foroven og Dele af Fundamentet var bevarede, saaledes at Portalen kunde restaureres i sin oprindelige Form, der for de aftrappede Kamms Vedkommende var noget anderledes end paa Nordportalen (Pl. VIII og Fig. 11). Det viste sig endvidere, at Granitkarme og Tympanon var de oprindelige og sad urørte i deres Leje i det oprindelige Murværk; kun synes Graniten at være blevet ophugget og forsynet med Affasning paa Hjørnerne i 1870. Ogsaa ved denne Portal var det saa heldigt, at en oprindelig tiloversbleven Formsten fandtes i det gamle Murværk og af en Form som ikke er benyttet ved de to andre Portaler eller andetsteds i Kirken. Med denne Formsten, tillige med den, der er benyttet i begge de andre Portaler, som Udgangspunkt er de nuværende Profiler komponerede i Analogi med Sydportalens Leddeling, — den eneste Sammenstilling der paa en harmonisk Maade kunde holdes indenfor Soklens Smigkant. Om den oprindelige Profilering af Portalen vides intet, da den som sagt allerede i Baroktiden blev omdannet. Indvendig har den Smige og pudset Bue, samt Bomhuller.

Ved Vestportalen er en Mærkelighed, der ikke er uden Interesse for Kirkens Bygningshistorie; det viste sig ved sidste Restaurering, da alt nyere Murværk var fjernet, at Taarnets Granitsokkel paa dets sydvestre Side havde fortsat sig ca. 50 cm ind i Portalfremspringet i absolut oprindeligt Murværk og med den gamle Mørtel, og at Murværket indtil 1 m over Soklen fulgte Soklens Retning bag Fremspringet, hvorimod dettes Murværk over denne Højde havde været i Forbandt med Taarnmuren. Ligeledes var Portalens indvendige søndre Smig ommuret helt op til Buens Vederlag, men *inden* Buen blev muret og Granitkarmen sat paa Plads. I Nordsiden var Murværket derimod homogent overalt og havde oprindeligt været muret samtidig med og i Forbandt med Portalfremspringet. Det synes da, som om man ved Kirkens Opførelse er naaet over 1 m over Soklen med Murværket syd for Portalen og

The western entrance has a feature which is not without interest for the history of the building of the church. Under restoration, when all the new masonry was removed, it was found that on the south-west side, the granite socle of the tower had continued about 50 cm into the projection of the entrance in absolutely original walls having the old mortar, and that these walls, one meter above the socle, followed the direction of the socle behind the projection, whereas *its* walls, above this height, were in bond with the walls of the tower. In the same way the inner south bevel of the entrance was re-bricked up as far as the abutment of the arch, but before the arch was bricked and the granite casement set in place. On the north side, however, the masonry was homogeneous everywhere and had originally been laid simultaneously and in bond with the projection of the entrance. It seems as if while under construction the masonry south of the entrance had progressed 1 metre above the socle, and first at that point, had it been decided to give the entrance a projection in contrast to the entrance in the south transept, which must have been finished at that time. The reason lies in the fact that it seemed dangerous to build the tower without the reinforcement which the projection of the entrance gave. Later, when the north tower was built, the necessity of the projection of the entrance was understood, and in the work done on this entrance there is no sign of uncertainty. In rebuilding the west and north entrances the granite socle has been continued as far as the granite casements. It is possible that this was not so originally, as the socle does not

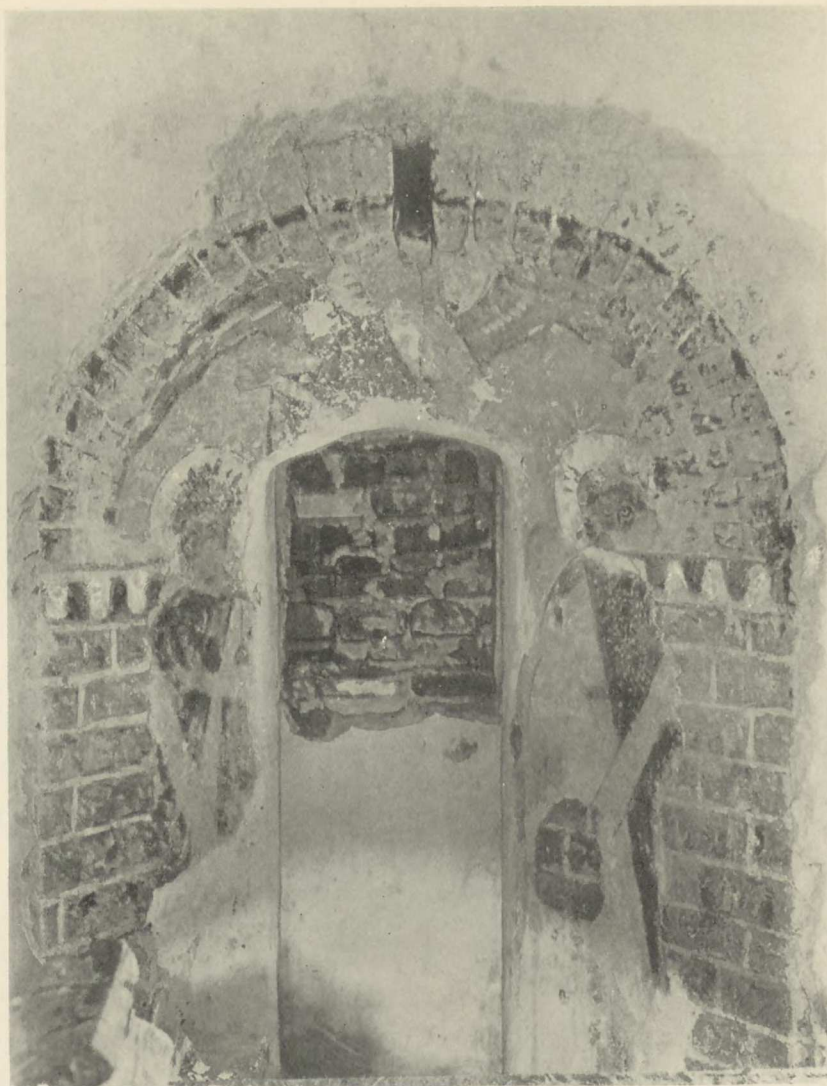
Fig. 14. Vindue i Koret. — Window in the choir.

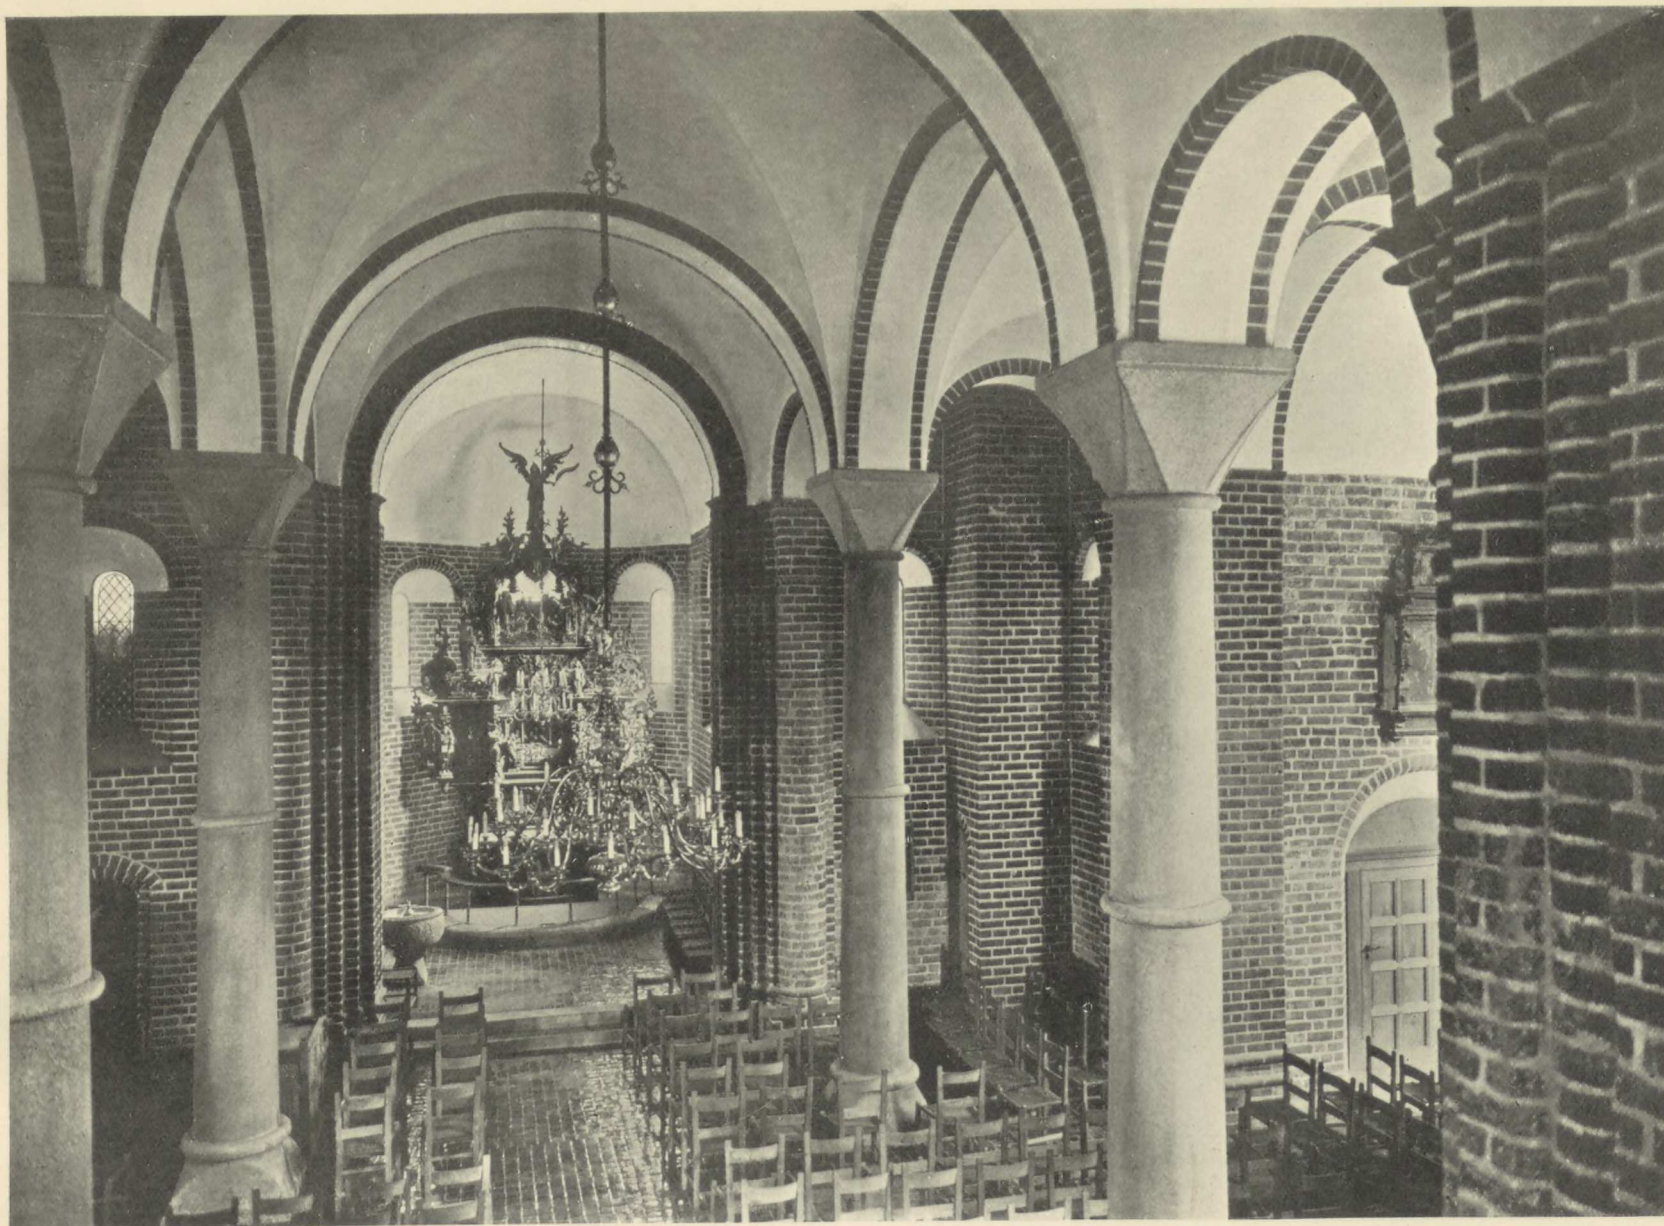
Fig. 19. Det Indre set mod Koret. — Interior looking toward the choir.

groove between the pilasters. The rather complicated system of pilasters, semi-columns and half-brick grooves is consistently carried out. Only that pilaster on which the semi-columns are placed ends on top without constructive intention for it is too broad in proportion to the capitals of the granite columns, the only point at which the judicious master-builder seems to have miscalculated. Of miscalculations of that nature, however, many an example is to be found in the architecture of the period. Very effective is the way in which the red edges of all the transvers arches are outlined against the white, thus setting off the construction of the church. (Fig. 19).

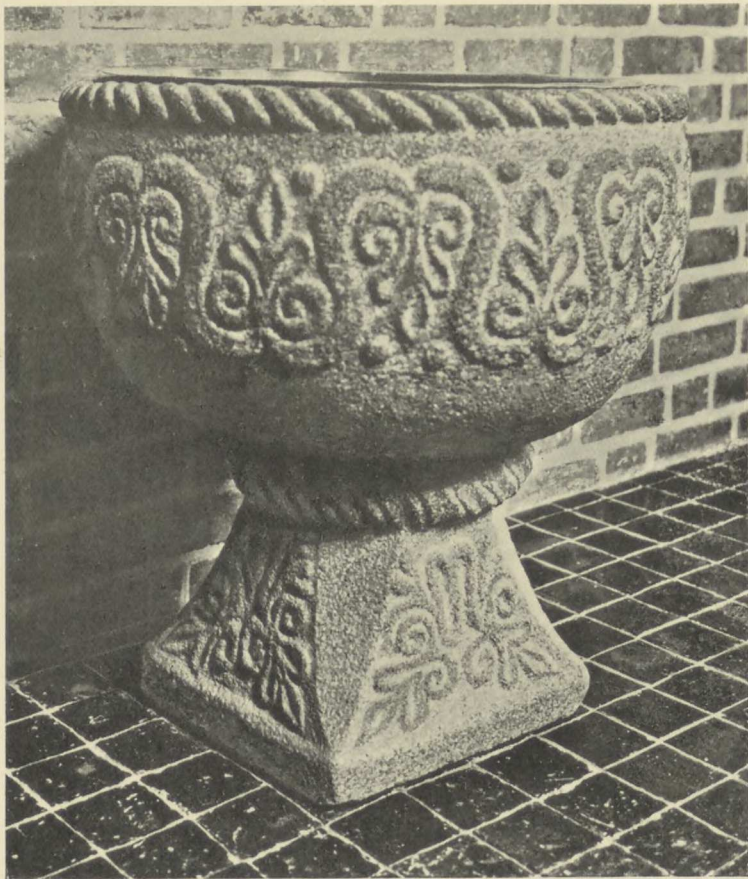
Fig. 28. Døbefonten. — Baptismal font.

Kummen er hugget af een Sten, som det er almindeligt, og har langs den øvre Kant en kraftig Tovsnoning. Paa Siden er i Relief et Palmetmotiv af lombardisk Oprindelse<sup>26</sup>. Foden er dannet som et omvendt Trapezkapitæl, der i Form ganske svarer til de fire Granitkapitæler paa Søjlerne i Skibet. Vulsten mellem Kumme og Fod bestaar af en Snoning af Hulkehlbaand, og paa Fodens trapezformede Sider er et Palmetmotiv i Slægt med Kummens. Døbefonten staar nu i Koret. —

Samtidig med Kirken er dens Døbefont af Granit (Fig. 28).

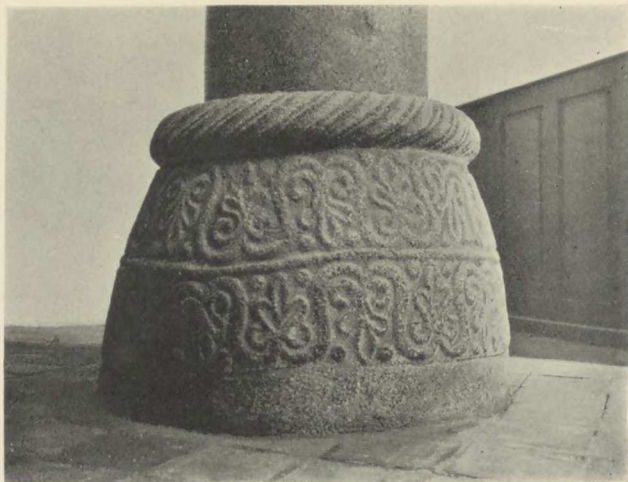
Fig. 30. Søjlebase fra Fjenneslev Kirke. — Base of column from Fjenneslev Church.
